TITLE: Oxygen System Hazards Analyses

PRINCIPAL INVESTIGATOR: Joel Stoltzfus

REPORT DATE: October 1996

TYPE OF REPORT: Final

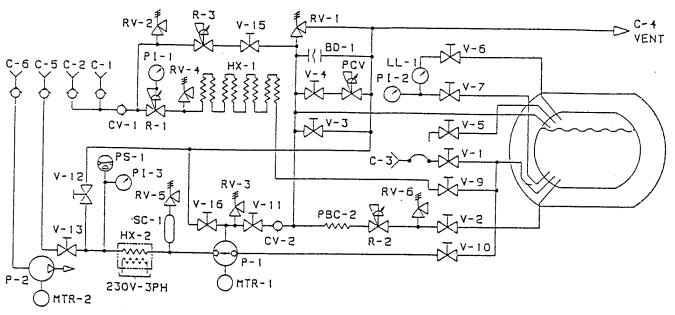
Figure 3
Recharger Oxygen Support Equipment Subsystem

The accumulator in this system, shown as SC-1 in Figure 3, was treated as if it were a section of stainless steel tubing. Therefore, no hazards analysis discussion is included for this component.

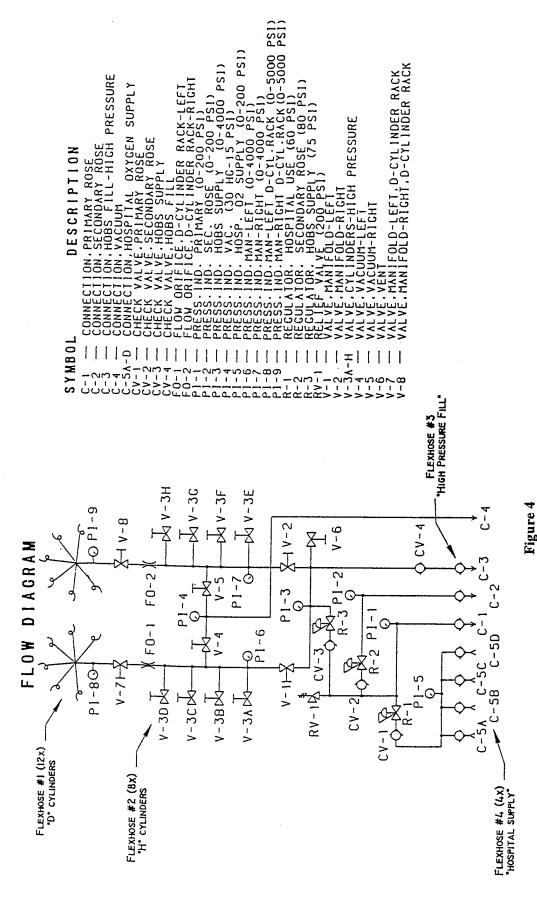
Figure 4
Hospital Oxygen Backup System

The HOBS is shown in Figure 4. Many components of this system are similar to components on the ROSE I. The operational procedures and conditions of the HOBS were considered and, in some cases, the HOBS components were analyzed only by similarity to their counterparts in the ROSE I. Thus, they were not considered in the HOBS analysis. Table 1 shows the components of the HOBS that were analyzed by similarity to their ROSE I counterparts.

The following is a general note that applies to all flexible hoses on the HOBS: It is recommended that operating procedures specify that the ends of all flexible hoses are to be inspected for cleanliness before connection.

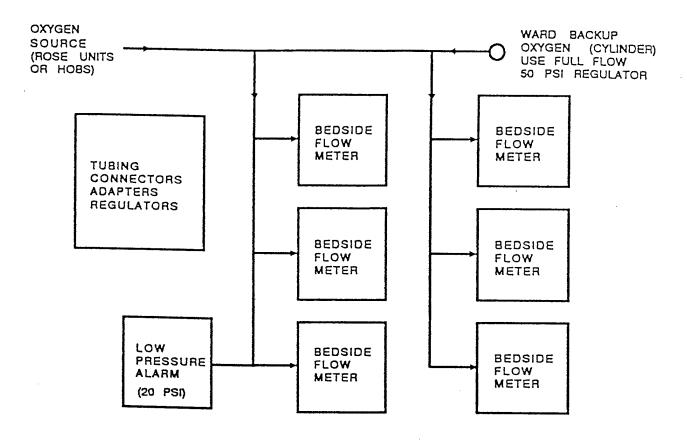
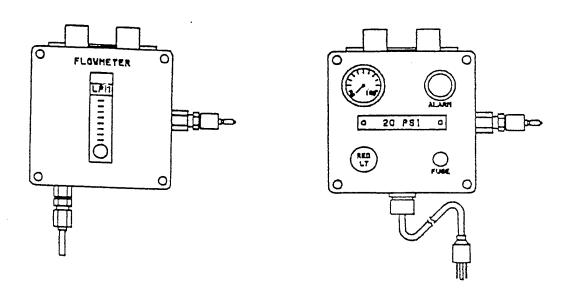
Figure 5
Patient Oxygen Distribution System

A block diagram of the PODS is shown in Figure 5. Oxygen is supplied to the systems through the ROSE I or HOBS units, or from a back-up oxygen cylinder. A low-pressure alarm signals when the gas pressure falls below the set minimum of 40 psig (0.3 MPa). Oxygen is distributed to the individual patients' beds through a flexible hose and a flowmeter. The maximum operating pressure from the outside components in the PODS is 60 psi (0.4 MPa).

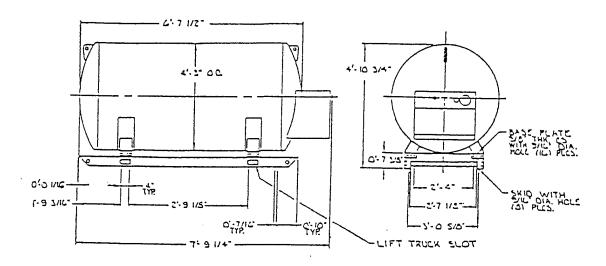
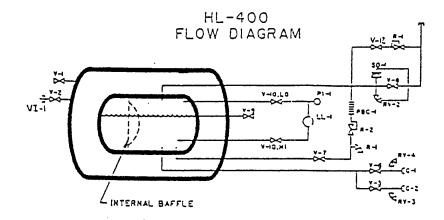
**Figure 6**Liquid Oxygen Buffer Storage Tank

The BST is shown in Figure 6. The BST is a 400-gallon LOX dewar. The operational pressure is 40 psig (0.28 MPa) maximum. The setting on the line relief valve RV-1 is 50 psig (0.34 MPa). The tank has a burst disc too, which is set for 75 psig (0.52 MPa). The BST flow system is similar in design to the ROSE I. Nearly all the components on the BST correspond directly to components on the ROSE I, both in material and configuration (Table 2). Also, the maximum operating pressure of the BST is less severe than that of the ROSE I. Therefore, the analysis of the BST was performed only through comparison to the ROSE I analysis.

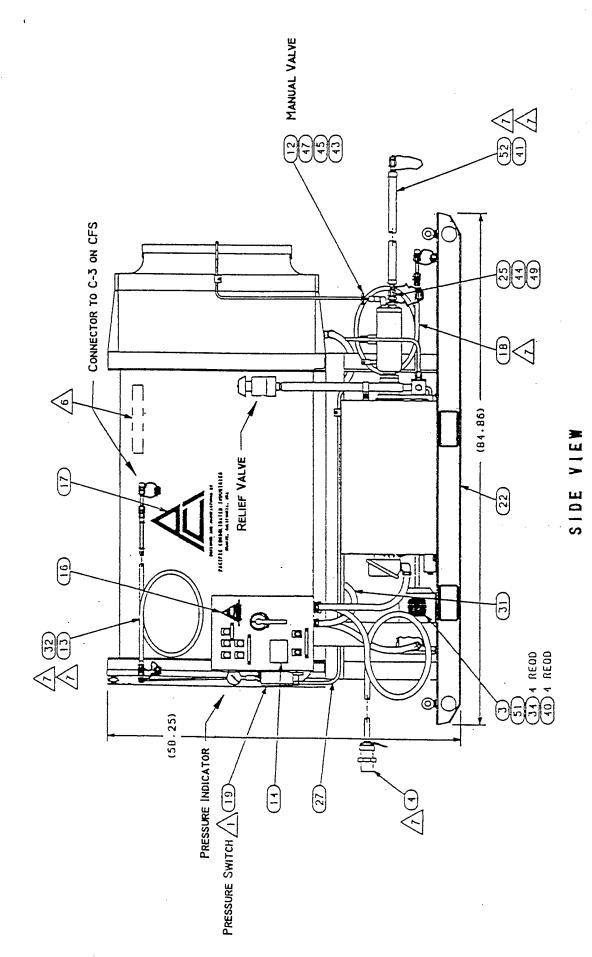
Figure 7 High-speed Recharger

The high-speed recharger is shown in Figure 7. The high-speed recharger is used to fill the oxygen cylinders in a short time frame. It fills eight cylinders in approximately 12 minutes. This component is not located in close proximity to the hospital. Again, similarities exist between this component and the previously analyzed ROSE I. The similarities are shown in Table 3. Because of these similarities, a component analysis will only be done on the LOX pump.
